## Inspection of Timber Bridges in the Pacific West (ID-150)

Tom Williamson, P.E.  
Managing Partner  
Timber Engineering LLC  
Vancouver, WA USA  
Lola Coombe, P.E.  
Civil Engineering Technician  
Rogue River-Siskiyou National Forest – USDA Forest Service  
Gold Beach, OR USA  
David Strahl, P.E.  
Structures Engineer  
Pacific Northwest Regional Office – USDA Forest Service  
Portland, OR USA

**Key Words:** field inspection, timber bridges, sawn timber, glulam, NBI ratings

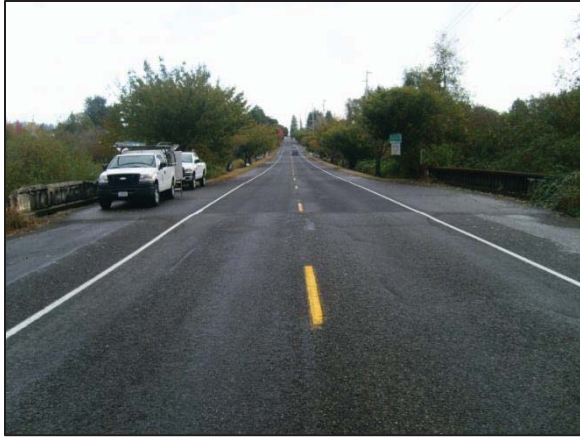
The Sylvia Creek Bridge is the oldest bridge inspected in the Pacific West region and is noteworthy in that it was originally constructed to carry 4 lanes of traffic. However, subsequent road construction in the county resulted in it only carrying 2 lanes with an ADT of over 4000 which was the highest for any bridge inspected in the region. This is shown in Figure 1. The bridge is posted for legal loads due to a badly deteriorated concrete guardrail system shown in Figure 2 which is well off of the travel paths and not planned for repair.

Figure 1 Sylvia Creek Approach

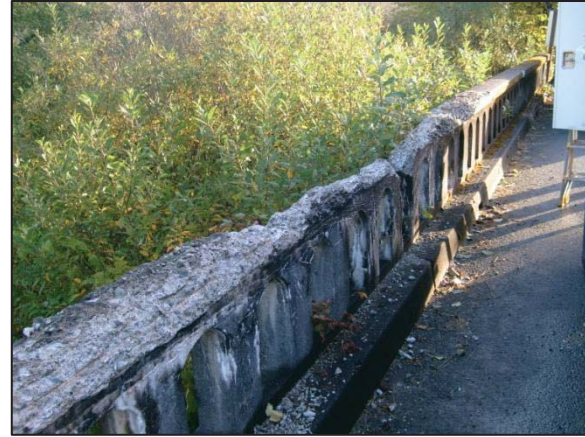
Figure 2 Sylvia Creek Guardrail

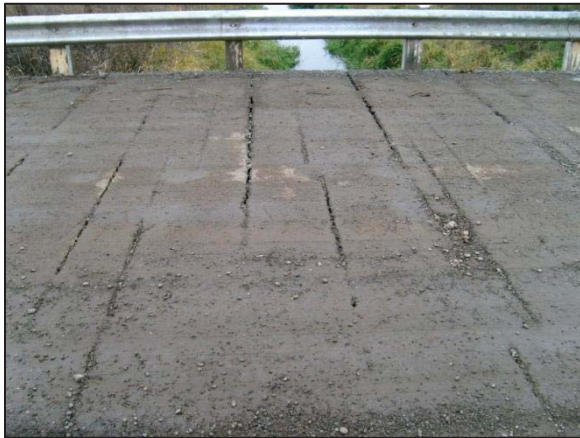
Since bridge 724 used untreated DF and has been in service for 54 years, it had relatively low NBI ratings as would be expected. The deck had numerous wide gaps (severe delamination) allowing moisture to readily penetrate to the girders below as shown in Figure 3. The result was high moisture content and moderate decay in several of the girders. Figure 4 shows significant checking in an untreated exterior girder.

Figure 3 Deck cracks in bridge 724

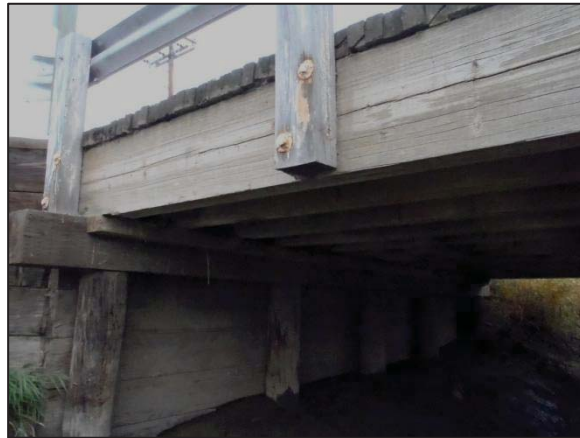
Figure 4 Untreated girder in bridge 724

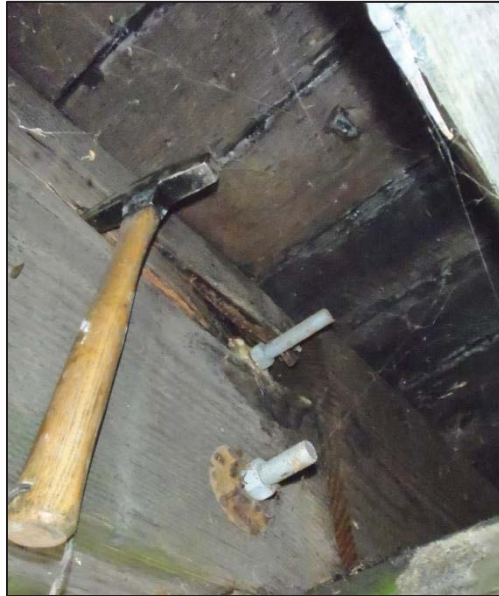
The timbers on the 5 multiple girder bridges were all creosote treated. These 5 bridges ranged in age from 38 years to 54 years. The decks were all plank deck systems in relatively good condition with NBI ratings of 6 and 7. The girders had NBI ratings from 4 to 7. The low rating of 4 for the exterior girders on bridge 1302 was due to the fact that 2 outside girders are badly decayed and need replacement as shown in Figure 5. Washington County has an excellent maintenance program and has replaced several girders and deck boards during the last decade as noted. With the exception of bridge 1293, which was recently resurfaced, the asphalt surfaces on the other 4 girder bridges have significant cracking and are scheduled for maintenance.

Figure 5 Decay in G14 of bridge 1302

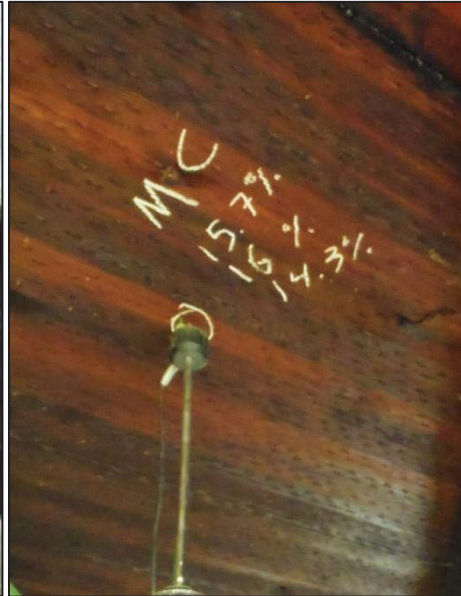
The two longitudinal glulam bridges were treated with penta in oil. While they have only been in service for 21 years, they are in excellent condition with moisture contents at 16% or below as shown in Figure 6. There is some asphalt cracking at the bridge ends and over intermediate piers on bridge 1358. The county is very pleased with the performance of these bridges.

Figure 6 Glulam deck on bridge 1360

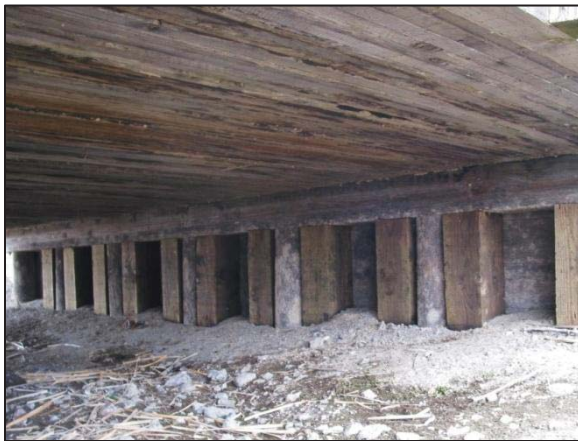
All of these bridges were in good condition with NBI ratings of 7 for the girders and decks. Figure 7 shows the typical condition of the slab deck bridges. The timbers were all creosote treated with the exception of the girders and deck on the Summers Lane Bridge which appeared to be treated with copper naphthenate as indicated by Figure 8. The bridges ranged in age from 31 years to 50 years. The asphalt wearing surfaces were all in relatively good condition with transverse cracks near the bridge ends being typical.

Figure 7 Longitudinal slab deck on Old Midland Rd. bridge

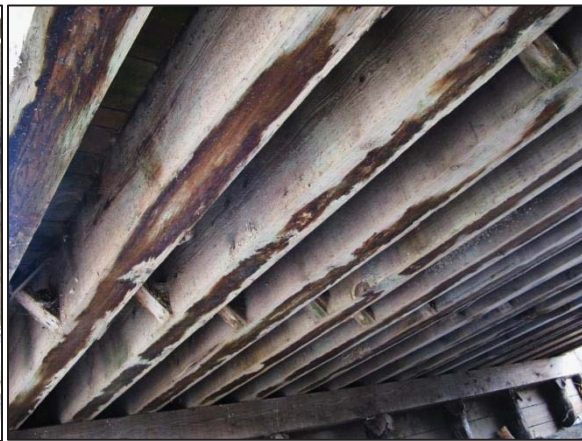
Figure 8 Sawn timber stringers on Summers Lane Bridge

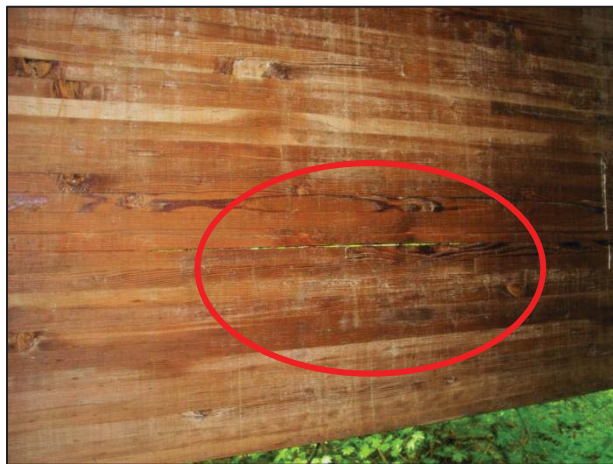
All of these bridges were in good condition with NBI ratings of 7 for the girders and 7 and 8 for the decks with the exception of the Griffin Creek Bridge. The girders for the Griffin Creek Bridge received an NBI rating of 4 due to the downstream 72 ft. span girder having a horizontal shear crack extending approximately 1/3<sup>rd</sup> of the span from the EOB abutment. Figure 9 shows the crack which is visible through the width of the girder and which resulted in a horizontal offset of more than 1 inch at the end. The remaining girders in the bridge were in good condition and would have an NBI rating of 7 similar to the other 3 bridges.

Figure 9 Horizontal shear crack in Griffin Creek bridge

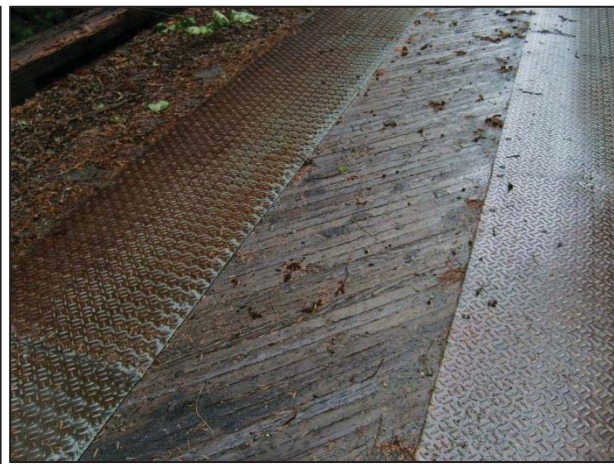
The glulam girders were all treated with penta in oil and the bridges ranged in age from 35 years to 46 years. The concrete decks were in good condition but two of them had some water ponding on them. The Knopki Creek Bridge was the only bridge inspected that had steel running plates as shown in Figure 10. Both the running plates and the transverse timber deck were in good condition after 46 years of in-service use.

Figure 10 Steel running plates and transverse timber deck on Knopki Creek Bridge

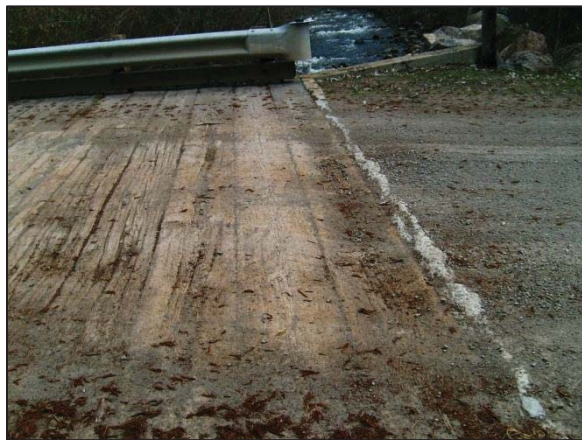
The Shovel Creek Bridge has sawn timber deck planks as the wearing surface and due to the traffic pattern, significant grooves exist in the two wheel paths as shown by Figure 11. This was the newest bridge inspected in the county and had the lowest NBI rating suggesting that using transverse deck panels functioning as the structural deck and the wearing surface is not conducive to longevity. The Red Bridge which has been in service for 54 years was unique in that it was the only bridge inspected that uses timber running planks as shown in Figure 12. It was considered to be in good condition considering the age of the bridge although one girder had previously been repaired using steel straps.

Figure 11 Wheel path depressions in timber deck on Shovel Creek Bridge

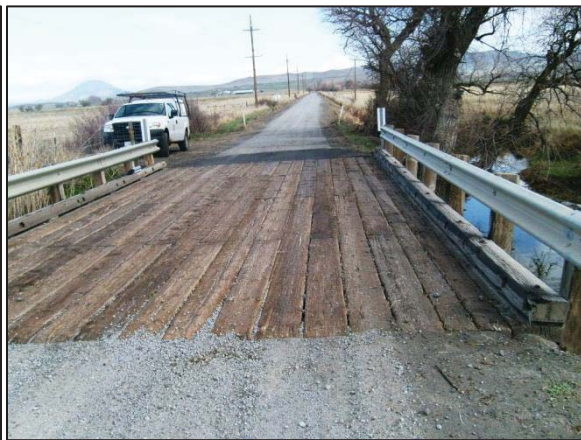
Figure 12 Timber running planks on Red Bridge
