A New Look at Modern Timber Bridges

Paul C. Gilham, P.E., S.E.¹

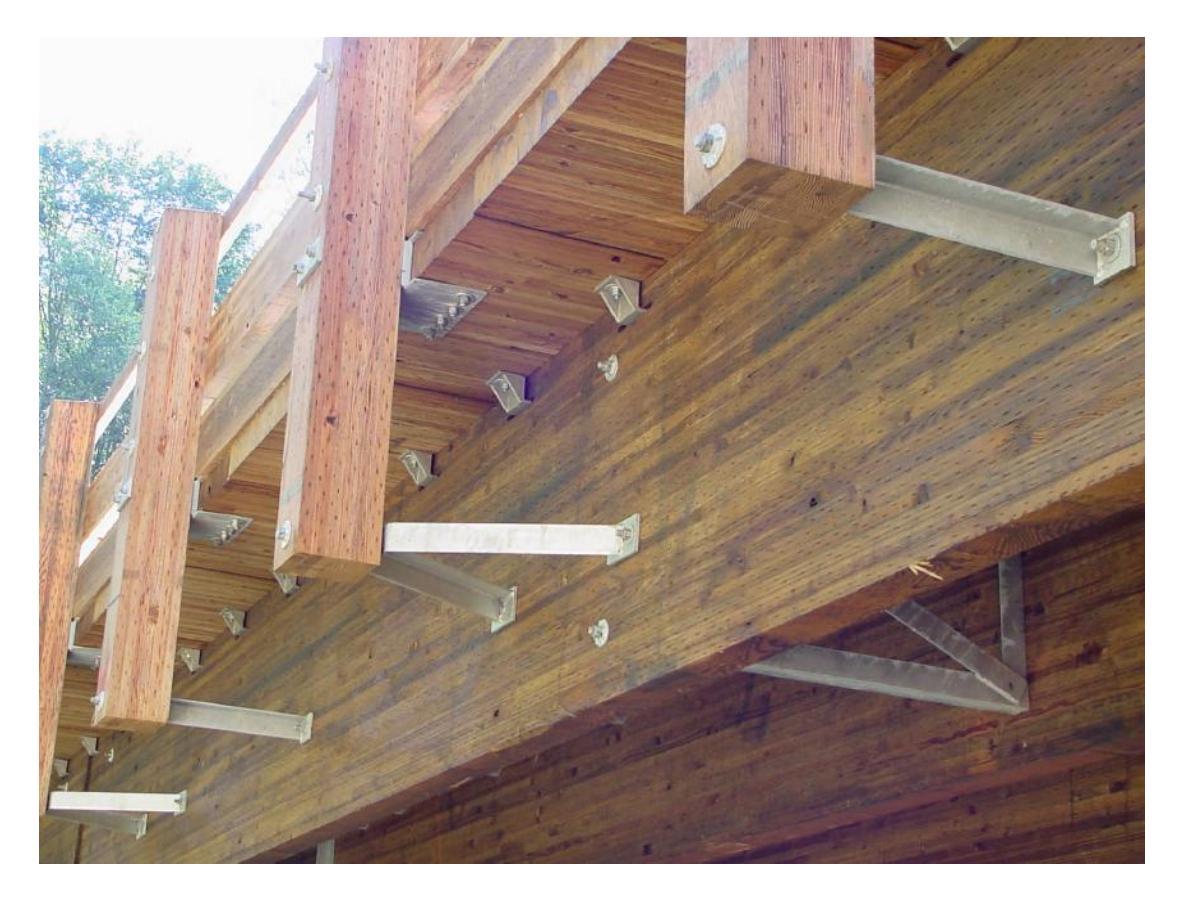
Photo 1. Timber Bridge with aluminum deck clips.

To avoid penetrating the treatment envelope, methods were developed to completely detail all of the bridge components, allowing the members to be completely fabricated before the members are pressure treated. Holes for beam seats, diaphragms, post and curb attachments are now drilled in a fabrication facility. Aluminum deck clips are now used to connect the deck panels to the longitudinal stringers. These clips grip a pre-routed slot in the girders without penetrating the treatment envelope. See Photo 1. Note that the timber girders were prefabricated for bolt holes at post braces and diaphragms. The deck and posts were prefabricated for the post brackets. This bridge was then preservative-treated with pentachlorophenol in heavy oil. Using these methods, moisture is prevented from reaching untreated wood and decay organisms cannot attack the wood.

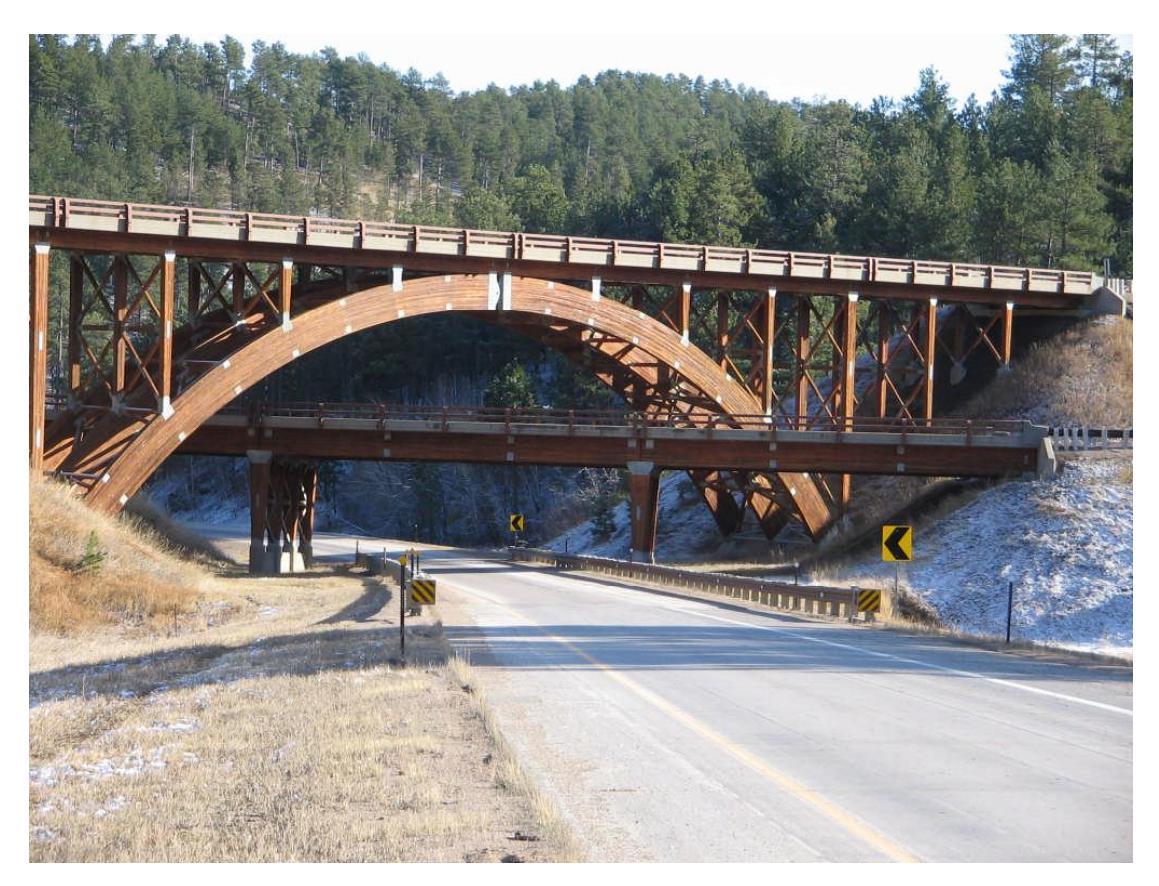
A notable example of a long lasting timber bridge is the Keystone Wye bridge on an interchange on US Highway 16 in South Dakota, near Mount Rushmore. This bridge was completed in 1968. Recent inspections have determined that this bridge is performing exceptionally well and will continue to do so for many years to come.

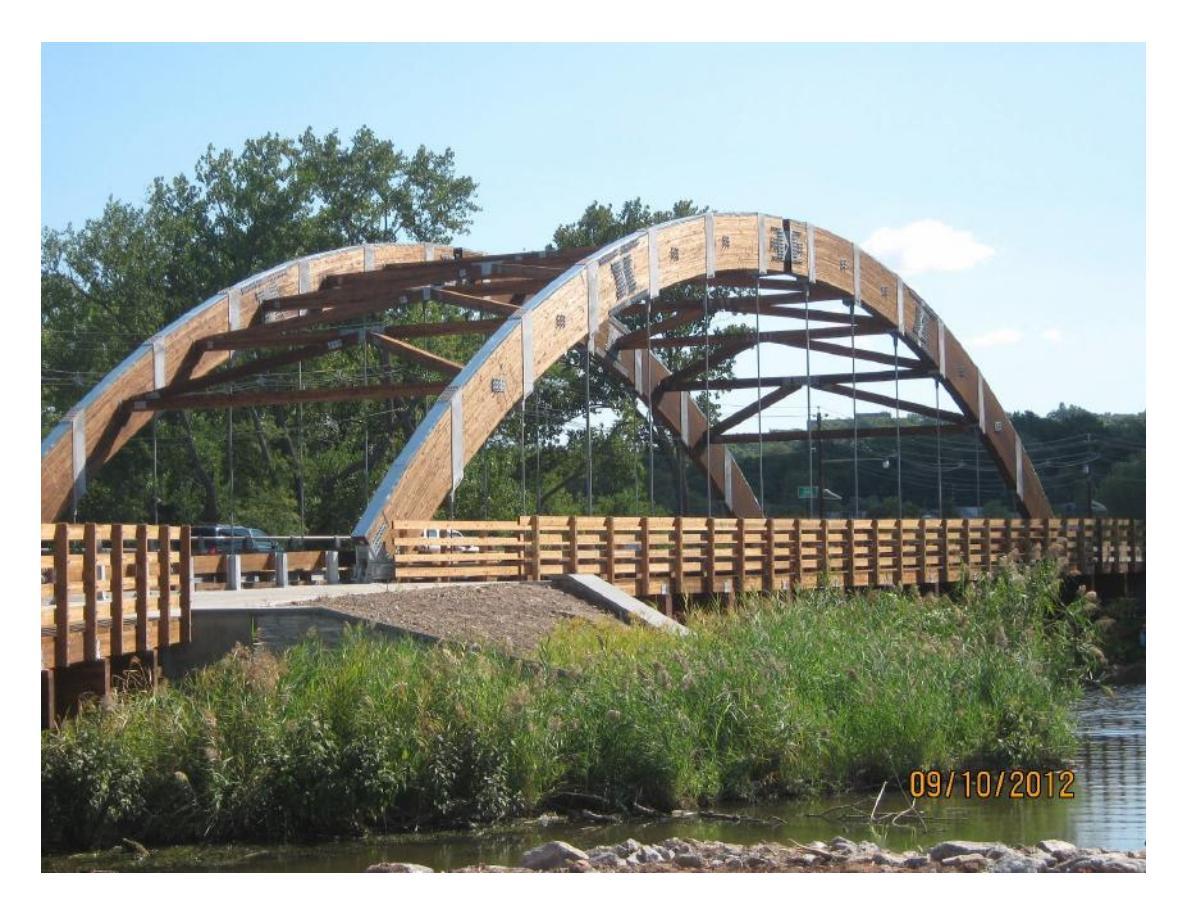
Photo 2. Overpeck Park Bridges in Teaneck, New Jersey are designed to carry two lanes of traffic with HS25 loading.

Truss Bridges and arch bridges are options for longer spans. Timber arch bridges can be designed to span 60m (~200'-0") and timber truss bridges can reach 90m (~300'-0") without interior supports. Figure 2 is a 42.67m (140'-0") tied arch bridge in Teaneck, New Jersey and Figure 3 is a 85.34m (280'-0") camelback truss bridge over the Placer River in Alaska. The foundations of this bridge were located in such a manner as to keep the bridge superstructure above the expected ice flows from Spencer Glacier located just upstream. This bridge is designed to carry a 6.04 kN/m² (126 psf) snow load which is roughly equivalent to HL-93 loading.

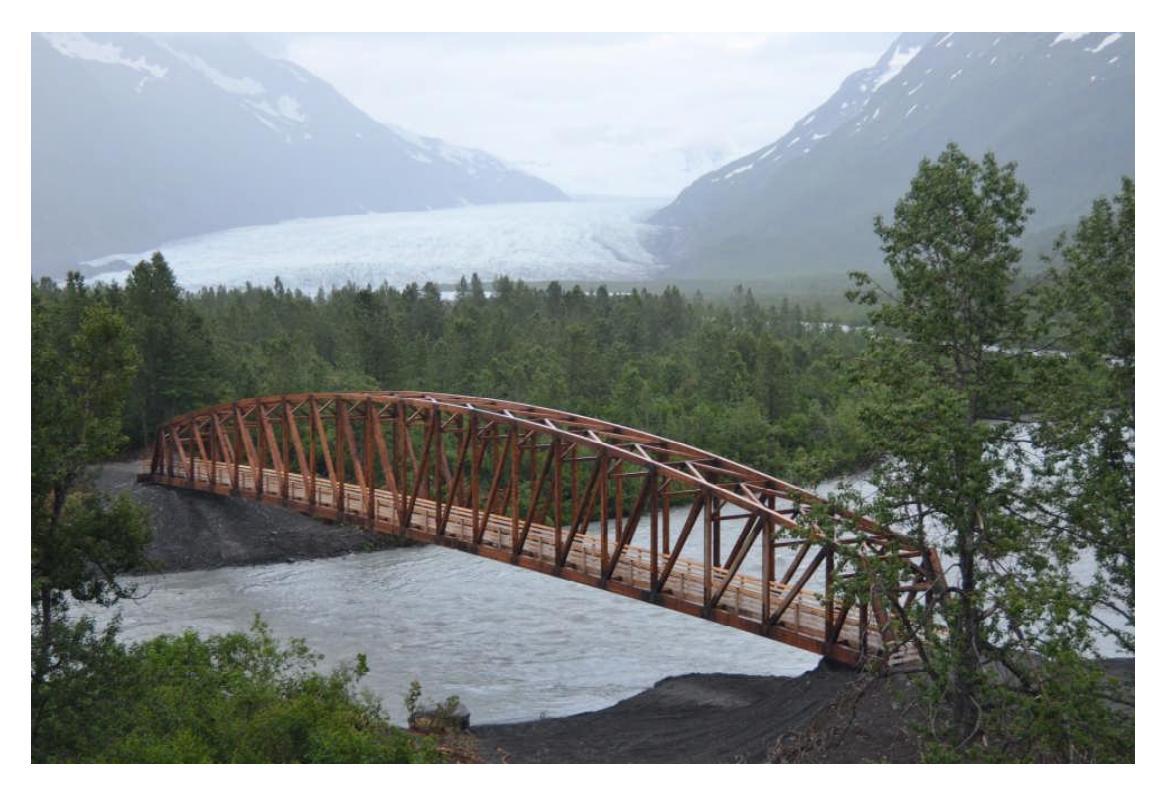
Photo 3. The Whistle Stop Bridge in Portage Alaska (Photo courtesy of Eleanor Oman, US Forest Service)

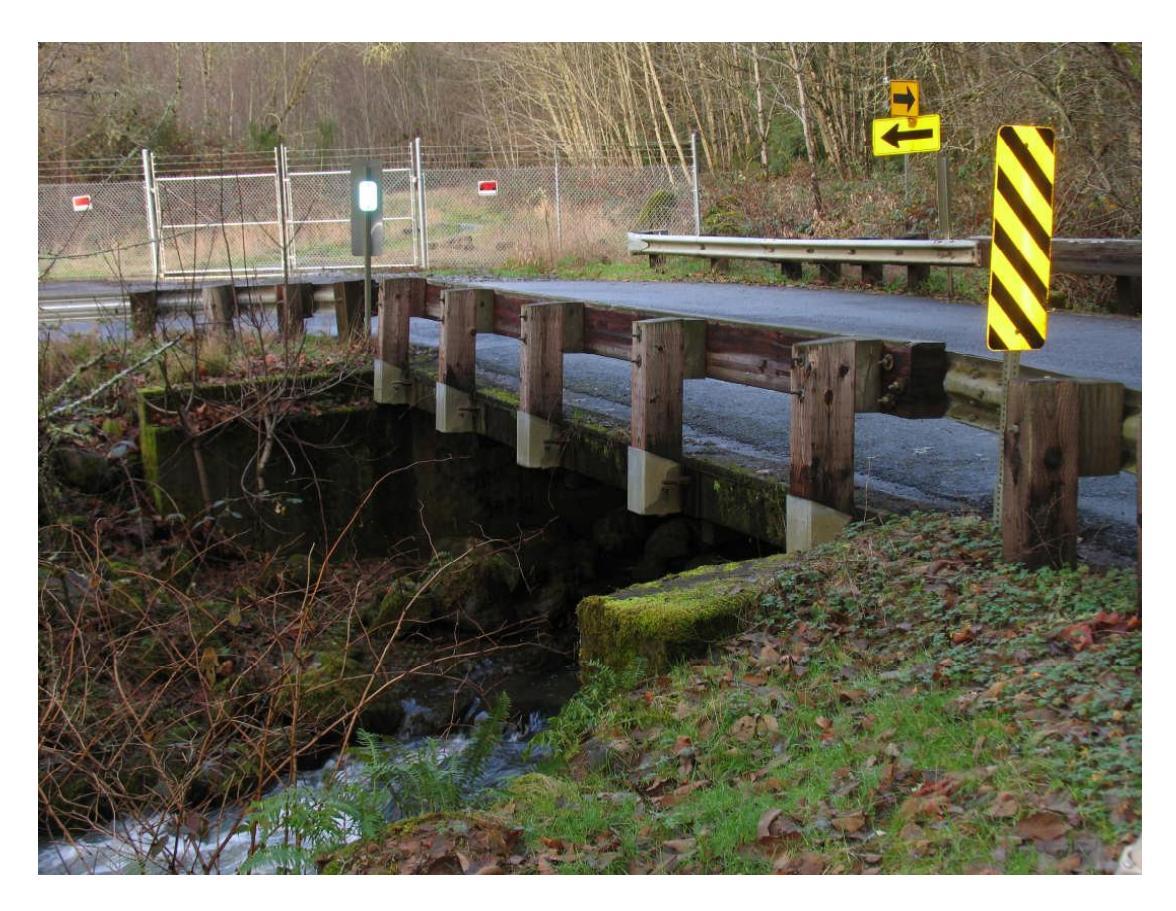
Photo 4. A timber longitudinal deck bridge with a TL-2 rail without a curb.

The US Forest Products Laboratory took a very proactive approach to this change in requirements and completed crash testing for longitudinal deck bridges (or slab bridges) and longitudinal stringer/transverse deck bridges for both TL-2 and TL-4 test levels. TL-2 railings are acceptable for most local and collector roads with favorable site conditions, as well as where a small number of heavy vehicles are expected and posted speeds are reduced. TL-4 systems are acceptable for the majority of applications on high-speed highways, freeways, expressways, and interstate highways with a mixture of trucks and heavy vehicles. Basically, a crash-tested system is available for any site where a timber bridge is considered. (Faller et al. 1999)

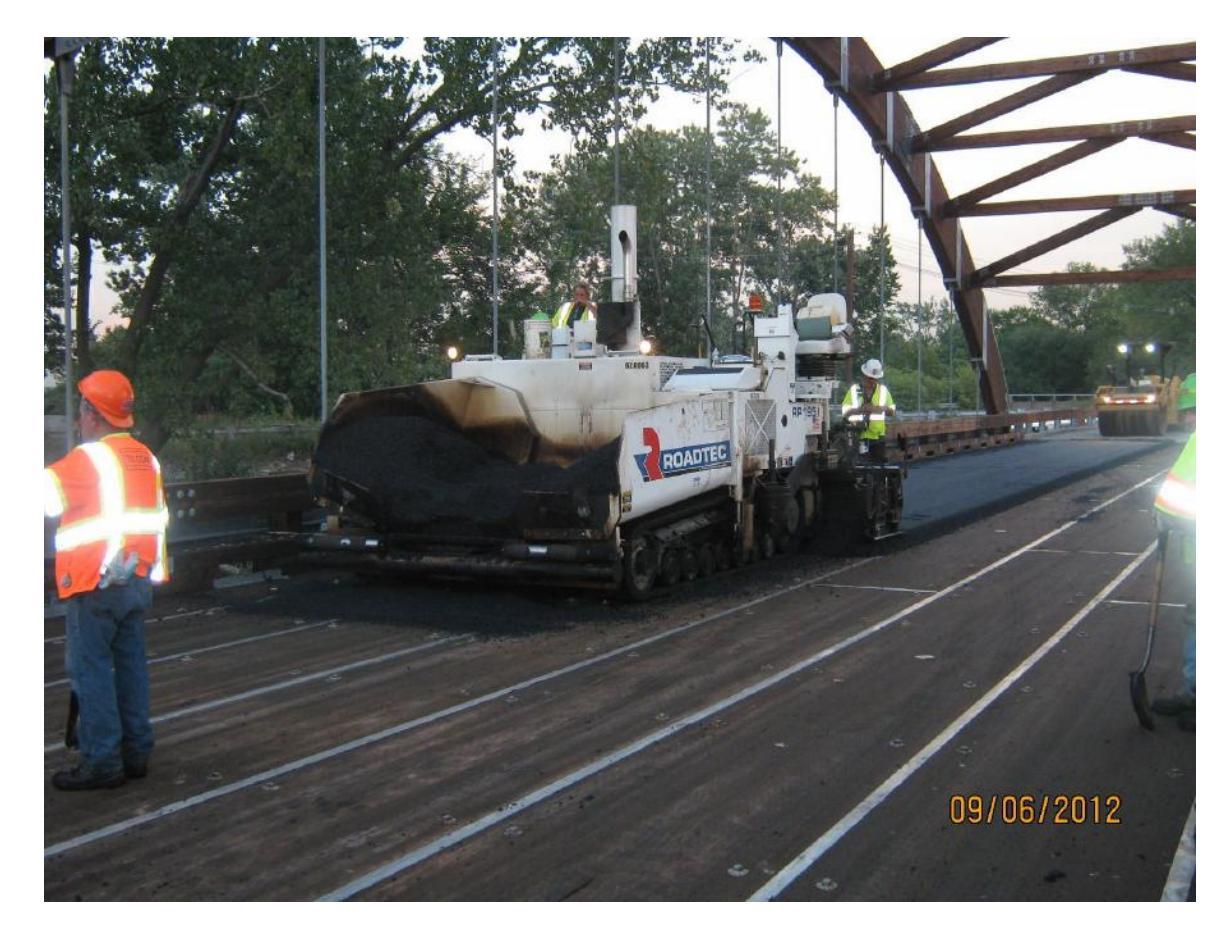
Photo 5. Paving operations on the Overpeck Park Bridges

Because timber bridges are constructed differently than steel or concrete bridges, material-appropriate designs and methods needed to be developed to allow the proper application of asphalt wear surfaces on timber decks. The Forest Service has developed extensive guidelines for asphalt pavements applied to timber decks. (Eriksson, et al. 2003) These guidelines include limiting deck deflections to1.27mm (0.05 inches), utilizing deck stiffeners to limit inter-panel deflections, specifying asphalt mixes compatible with treated timber, minimizing preservative treatment residue on the deck surface, and applying a paving membrane on top of a base layer of asphalt. See photo 5. Using these guidelines, the asphalt wear surfaces can be applied that show no signs of reflective cracking.

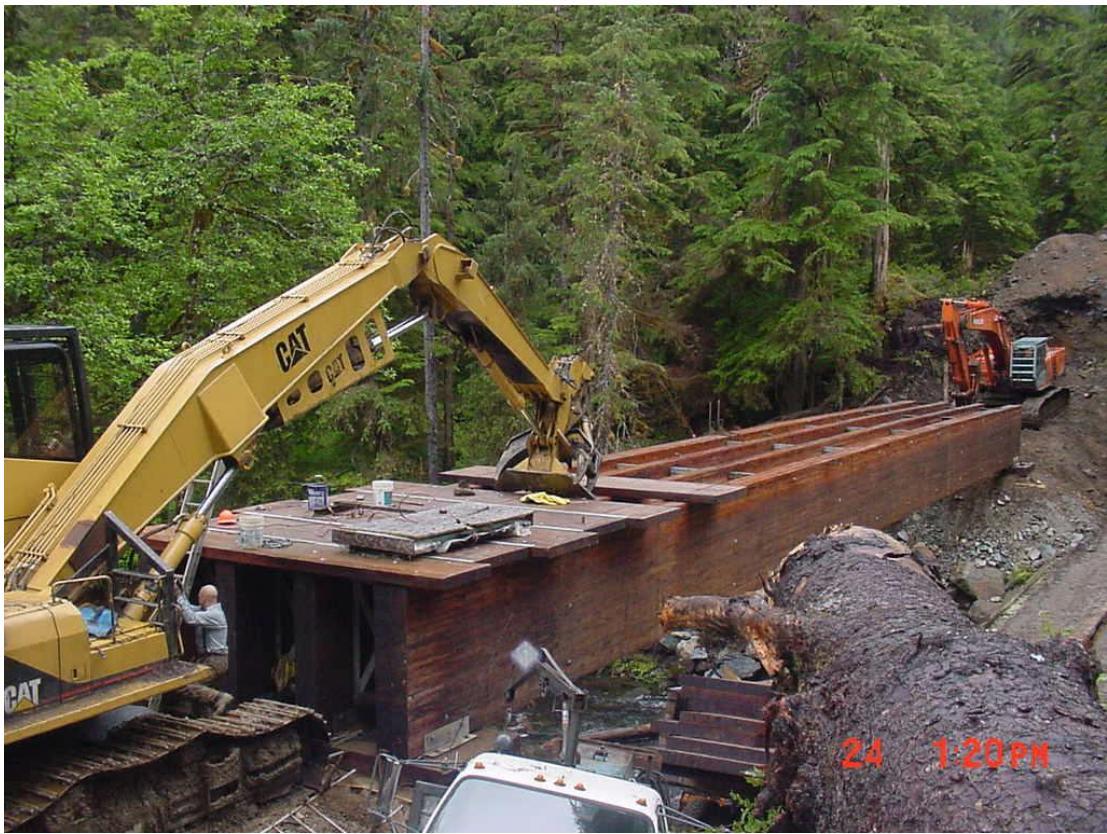
Photo 6. Alaska Logging Bridge using backhoes for installation. (Photo Courtesy of Eleanor Oman, US Forest Service)

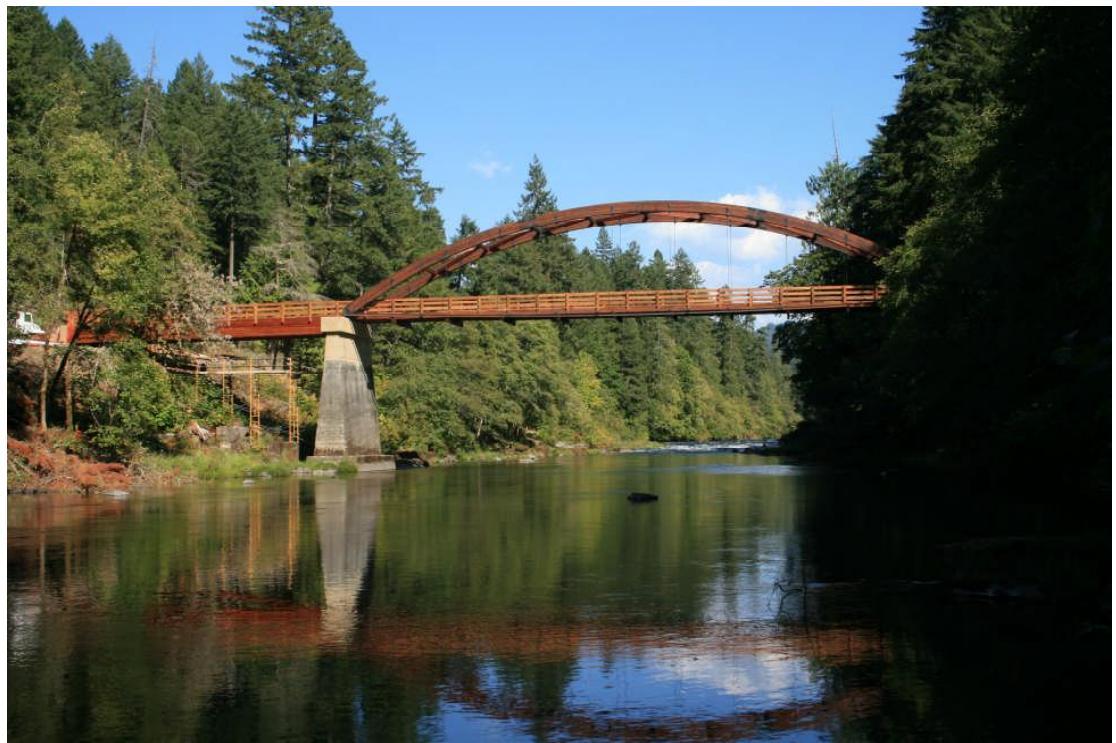
Photo 7. Tioga Bridge over the North Umpqua River

The AASHTO LRFD Bridge Design Specification states that, "bridges should complement their surroundings, be graceful in form and present an appearance of adequate strength." (AASHTO, 2010) This criterion is easily achieved with the use of timber bridges, especially in rural and natural settings. Treated wood blends into natural sites in ways that other bridges cannot. For example, The Oregon Department of Transportation and the US Bureau of Land Management chose a timber bridge to provide access to hiking trails on a high profile project in southern Oregon. The Tioga Bridge in southwest Oregon fits beautifully in its location spanning the North Umpqua River (Photo 7.)
